Harbor Offshore, Inc.

Century Link
San Juan Islands Cable Repair
San Juan Island, WA

General scope of the project:

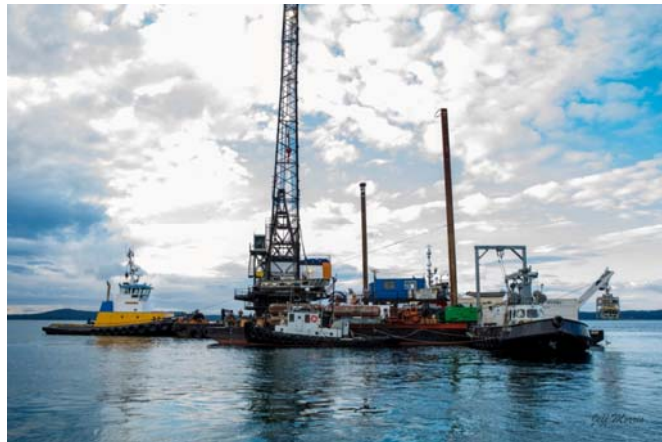
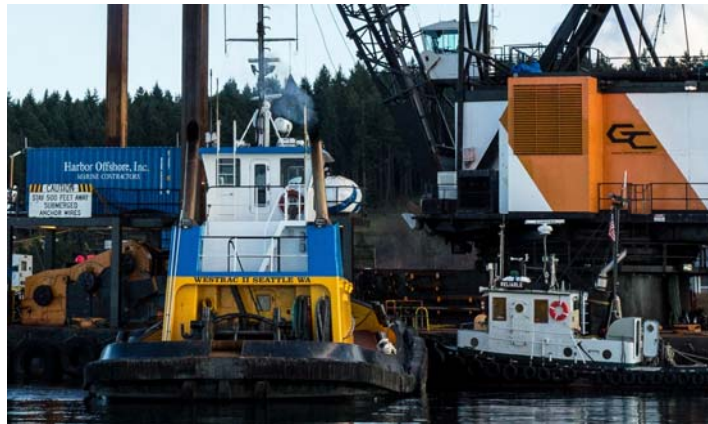
Recover severed cable end in 300 feet of water. Splice repair cable to end and relay new cable to Lopez Island. This was done in an active cable crossing with 2 other live power cables in the immediate area. The entire operation was performed without anchors by holding station during the splice and lay. Currents were measured as high as 3.5 knots

On November 5, 2013, there was an outage of the cable between Lopez Island and San Juan Island. The repair spread was working onsite by November 10 and the repair was completed by the 16th. Harbor Offshore provided highly valuable operational and technical expertise during the rapid planning and execution of this project. Harbor Offshore organized and directed the mobilization of equipment and the conducted the successful on-water repair. This involved the utilization and direction of numerous subcontractors with equipment and specialized capability in use of dual tractor tugs, hi-current ROV, derrick barge, acoustic subsea positioning, surface positioning, mixed gas diving and fiber optic splicing.
